The Right Stuff BY STEVE ZIMMERMAN

The engine room on this Krogen Express illustrates a number of best practices.

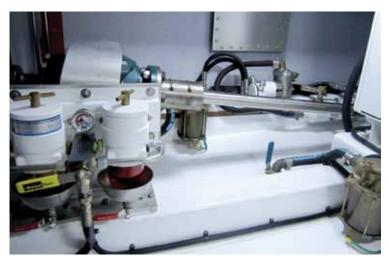
Both Racor filters have been installed in an easily accessible location and they have the proper metal heat shields installed to comply with ABYC guidelines. The valves at the bottom of the assembly are critical—if spring loaded, they might develop leaks and if plastic they might melt in a fire. The valves shown do not rely upon plastic or springs, and the 90-degree rotation allows you quickly to see if they are open or closed.

In addition, a drain plug has been fitted below the valve, eliminating the possibility of an accidental leak. The vacuum gauge installed between the filters has a tracer needle. The tracer needle remains at the highest vacuum reading since last reset, enabling the boat owner to easily identify developing problems developing in the filtration system.

This boat has been equipped with an AquaDrive® antivibration system. On most boats the force of the propeller transfers to the shaft, to the engine, and then onto the engine mounts. The mounts must be robust to withstand this force, and the stiffer the mount, the more vibration transmits to the stringers and then throughout the vessel. This AquaDrive® system transfers the load directly to the stringers, keeping the forward force off of the engines. A heavy aluminum fabrication can be seen above and below the fuel filters (the filter assembly has been mounted onto the aluminum frame). This component receives the load from the prop and shaft and transfers it to the stringer, isolating the engine. The engine mounts no longer take the load and they can be much softer, allowing the engine to float, thereby greatly reducing vibration transmission. For added protection, the setscrews on the shaft coupling have been "moused," or safety-wired to prevent them from turning loose.

The clean, bright white bilges will quickly expose any fluid leaks, and ample inspection port on the inboard face of the fuel tank provides good access for cleaning a fouled tank. The two raw-water strainers have been installed vertically, enabling the boat owner to clean them without dumping fouled water into that clean bilge, and the seacocks are conveniently close. A properly sized (#8 AWG) bonding wire has been well secured with ring terminals and a machine screw, ensuring a reliable low-resistance connection for the bonding system.

This engine room shows a nice balance of access and convenience—components are close together yet easy-to-reach. All in all, many examples of the right stuff. ■
